**US Army Corps
of Engineers®**
Engineer Research and
Development Center

Navigation Systems Research Program

Detection and Evaluation of Scour Protection for Navigation Dams

August 2008

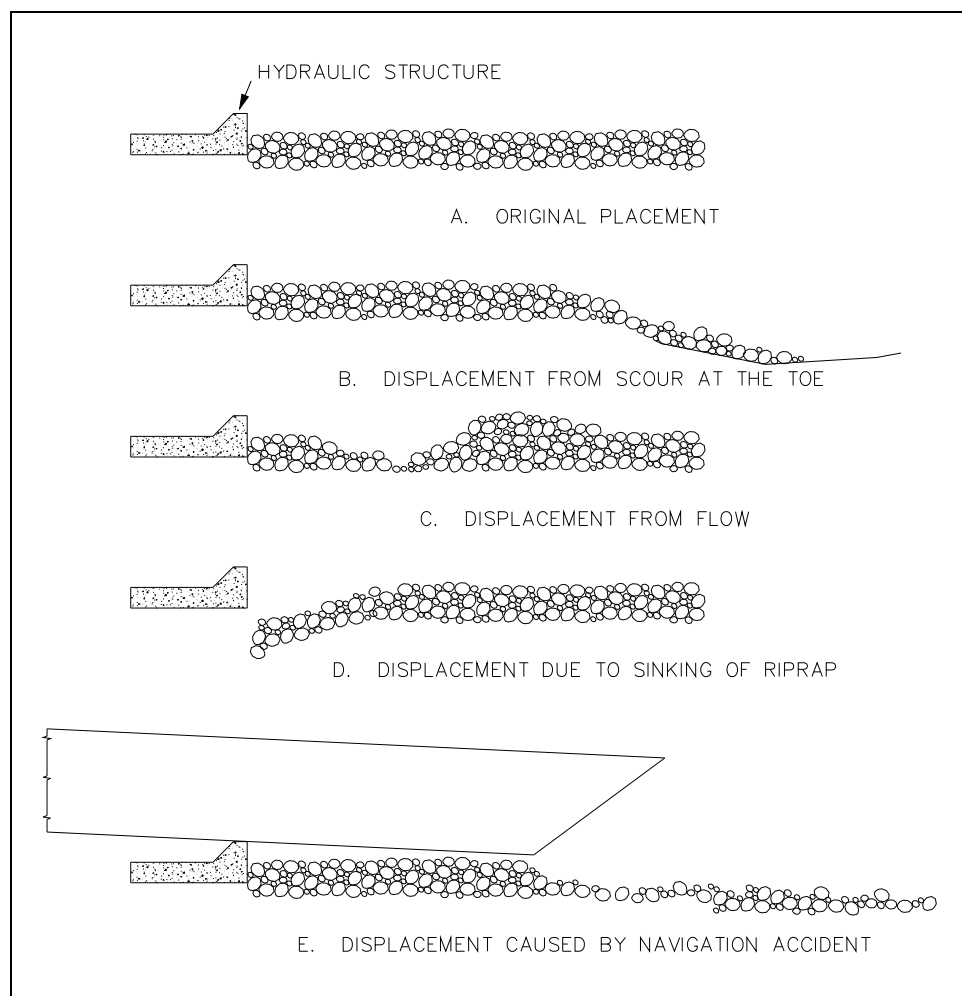
Figure 1. Examples of scour.

Scour at navigation projects is generally associated with displacement of the stone protection. Failure of a riprap blanket adjacent to a hydraulic structure can be caused by several factors. Failure is generally considered to be displacement of sufficient riprap to jeopardize the structural integrity of the hydraulic structure the riprap is intended to protect. Some of the more common examples of displacement are shown in Figure 1.

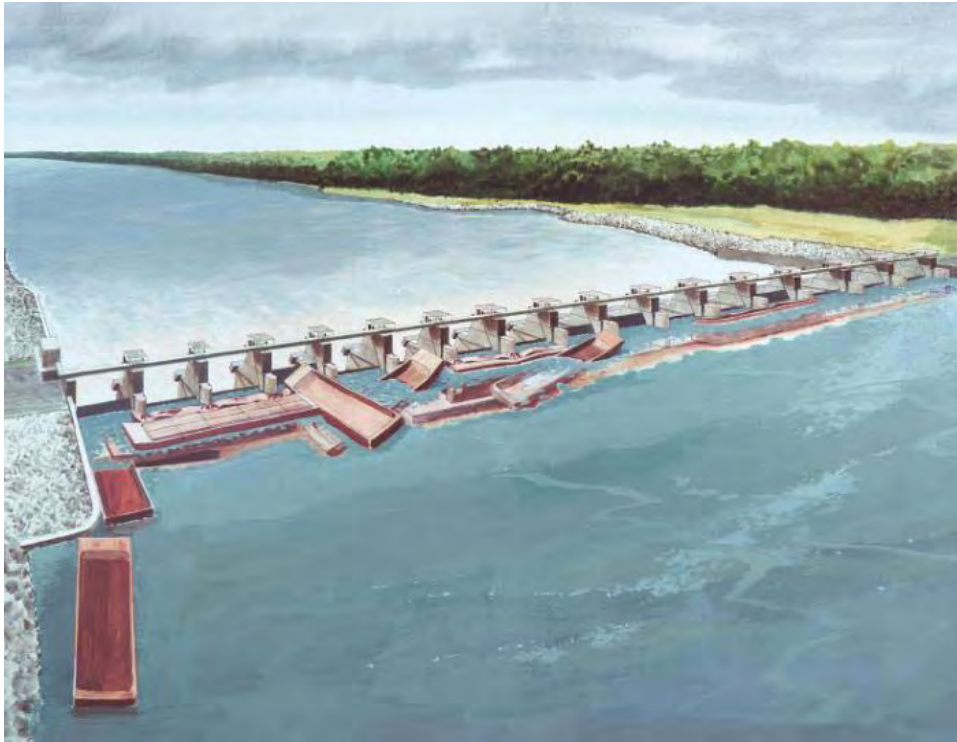
Figure 3. Artist's rendition of barge accident at the Wilbur Mills Dam, Arkansas River.

Riprap displacement from a navigation accident can be rapid and severe. The probability of failure can be high if the vessel or barges impact the riprap protection or sink and rest on the protection. Several accidents have occurred where both loaded and unloaded barges have impacted the navigation dam with the barges either passing through the structure or becoming lodged against the structure. Several situations can result from a barge accident. The gates can be damaged and normal operations are not possible. If the head becomes greater than normal and the tailwater drops below normal from insufficient discharge through the gates, scour can occur. Barges that have sunk and lodged against the upstream side of the dam can concentrate flow and cause extreme scour locally, as illustrated in Figures 3 and 4. The accident shown in Figure 3 caused significant scour both upstream and downstream from the dam. Following the accident, a secondary stilling basin was constructed from sunken barges filled with riprap and grout to prevent loss of the dam should an accident similar to this one occur again. The accident shown in Figure 4 resulted in loss of the navigation pool, with significant economic impacts.

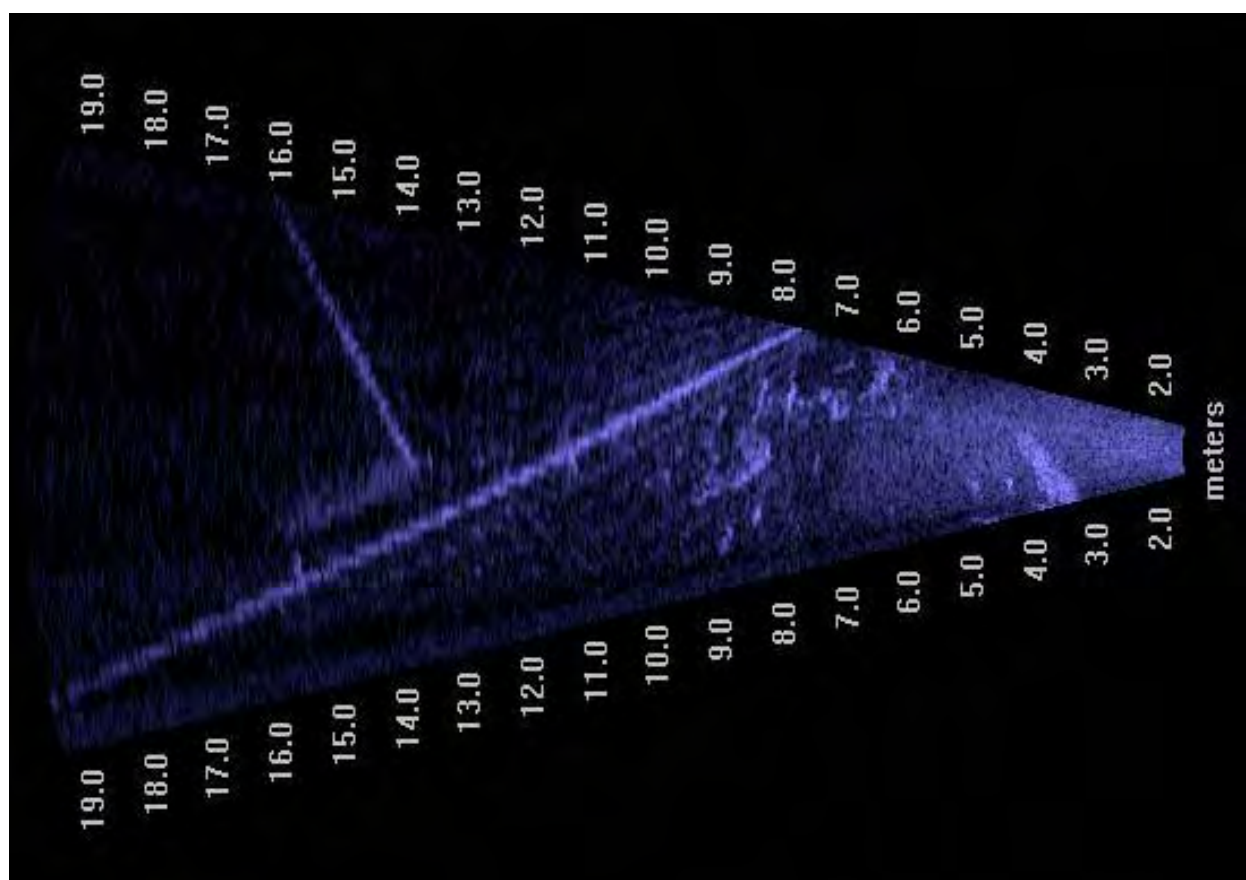
Figure 20. Area just south of the pier between gate bays 9 and 10 (Test 1).

The numbers are the distance in meters from the DIDSON to the feature imaged. The area on the south side of the pier between gate bays 9 and 10 (pier 9-10) is shown in Figure 20. The edge of the apron is the long slightly angled feature and the south edge of the pier 9-10 is the feature normal to this one.
